The Influence of the Relative Sliding on the Surface Quality

This paper presents a study on the surface quality pointing out the influence of relative sliding on the topography parameters. Traditional roughness parameters as R_a and R_q , deal only with relative high of the asperities to the mean line and they give no information on shape, slope and asperities magnitude, on their appearance frequency on the profile length. The authors analysed a set of 3D parameters including the amplitude ones (S_a , S_{ku} , S_{sk} and S_t) and functional parameters as S_{vk} , S_k and S_{pk} as calculated with a dedicated soft from the bearing area. Tests were done on roller-roller tribotester lubricated with the grease grade UM185Li2EP (general purpose grease for rolling bearings), the temperature of the environment being kept at 80°C. There was studied the influence of relative sliding speed on the skewness and the kurtosis of the surface topography, but also on common parameters as S_a and S_t . Such a study may be used for selecting a suitable surface quality and to evaluate the surface topography degradation in time, after tests under severe conditions, very close to the actual ones.

Keyw

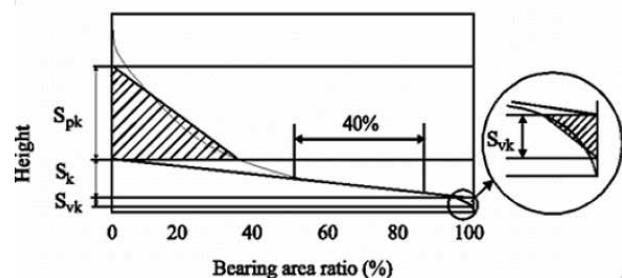
Figure 1. Bearing curve illustrating the calculation of S_{pk} , S_k and S_{vk} [6]

The functional parameters are described graphically in Figures 1 and 2.

The reduced summit height, Spk , is the height of the upper left triangle [6]. The core roughness depth, Sk , is the height difference between the intersection points of the found least mean square line. The reduced valley depth, Svk , is the height of the triangle drawn at 100% (Figure 1).

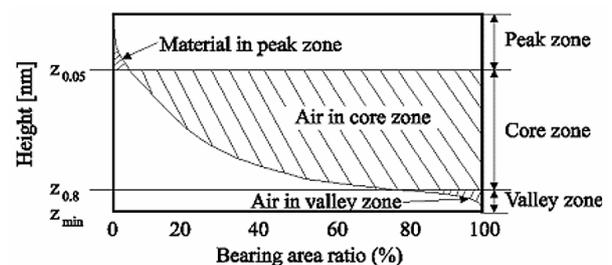
Figure 2. Bearing curve illustrating the calculation of S_{bi} , S_{ci} and S_{vi} [6]

The surface bearing index, Sbi [μm], is defined as:

The core fluid retention index, Sci [μm], is defined as:

The valley fluid retention index, Svi [μm], is defined as:

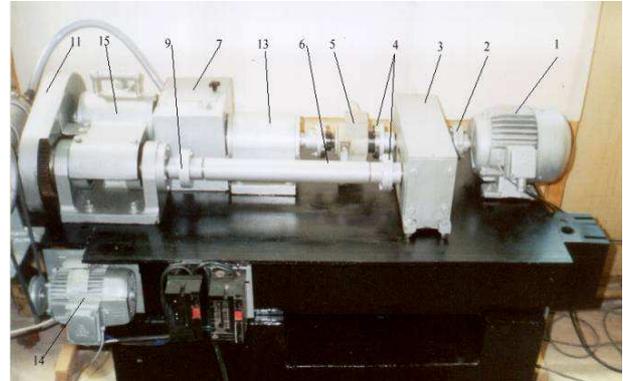
Figure 3. The testing machine 1– driving electric engine; 2, 4, 9– rigid coupling; 3– gear transmission; 5– torque transducer; 6– intermediate shaft; 7– thermoisolant box; 8 – tested rollers (in box 7); 10– force transducer; 11– reducing gear box.

Tests were done on a roller-roller tribotester (Fig. 1) [2]. The test conditions were: normal load $Q=1.0$ kN, enclosure temperature $\theta=80^\circ\text{C}$, rolling speed (for $\xi=0\%$) $v=1.09$ m/s, testing period $t=240$ minutes, lubricant: grease grade UM185Li2EP (general purpose grease for rolling bearings), diameter of rollers for pure rolling $D=42.0$ mm, contact width $B=10$ mm ($B_{\text{roller1}}=10$ mm, $B_{\text{roller2}}=12$ mm)

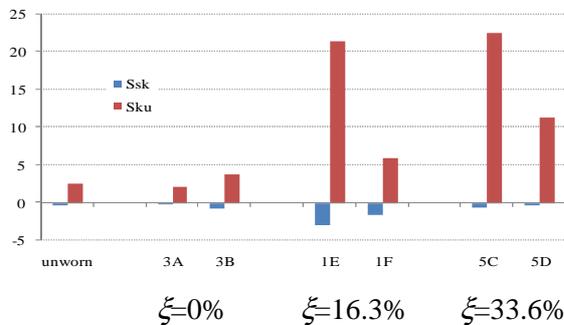
Figure 5. Amplitude parameters Ssk and Sku for the tested rollers

Sku increases for all tested surfaces, but especially for rollers with relative sliding, meaning that the relative sliding could generate a distribution with rare but narrow peaks. The values are much lower for the steel grade OLC45 and for this steel grade the influence of relative sliding seems to be almost linear under the test conditions. For the steel grade OLC 25 both values of relative sliding have generated close values for this parameter. Sku has the largest spread range,

The negative values for Ssk point out there are holes in the surface topography, deeper for $\xi=16.3\%$ and for this test, for the roller made of steel grade OLC25.

Ssk has a similar trend for the highest relative slide ($\xi=33.5\%$). Due to this value the asperities are “micro-grinded” and Ssk is similar to the initial ones. High relative changes of these two parameters (Ssk and Sku) for the worn surfaces are also reported by Krzyzak in [5].

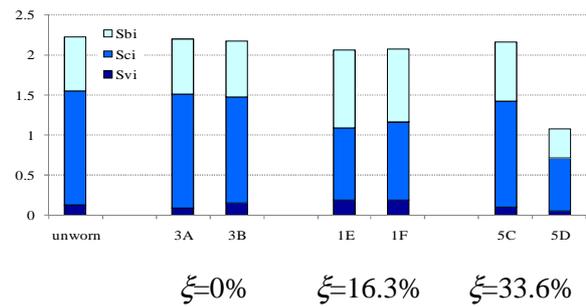
Figure 6. Functional parameters Sbi , Sci and Svi for the tested rollers

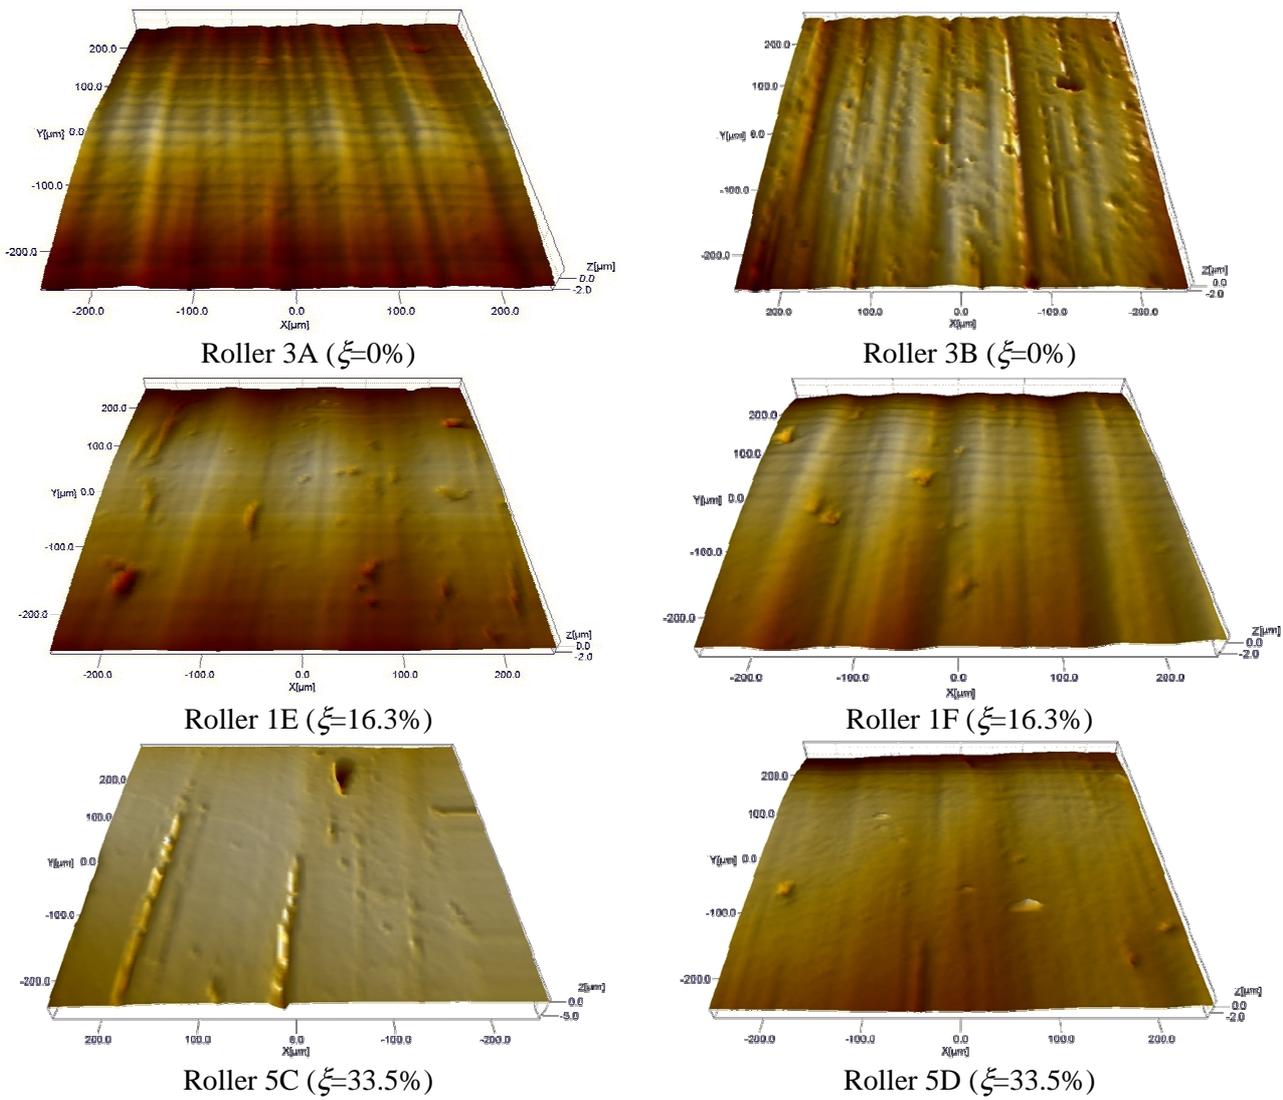
Figure 8. Virtual images of the investigated surfaces

about 8...9 times greater than the initial value. Figure 8 presents images of the worn surfaces as being rebuilt based on the measured coordinates and these images reveal isolated deep valleys.

Comparing images from Figure 8 (rollers 3A and 3B) and Figure 10 (rollers 4A and 4B), one may notice that the damaging processes of the surface are similar, but more intense for the rollers bearing $Q=1.0$ kN. The higher load reduced the amplitude parameters like S_a , S_k and S_t (Figure 11). S_{sk} remains in the negative range for $Q=1.0$ kN, but for $Q=0.7$ kN there were recorded values giving a positive average (Figure 12). Under this load and pure rolling, the higher isolated peaks may be less damaged as compared to those under a rolling-sliding motion. It could also be the consequence of adhesive wear (isolated high peaks above the surface could be seen in Figure 10, suggesting wear debris adhered on the roller surface).

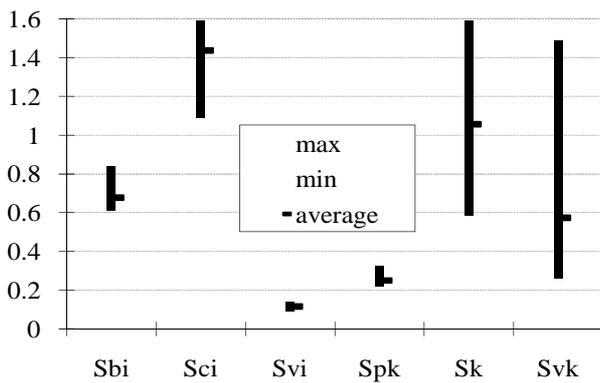
Figure 9. The spread range for functional parameters for roller 5C (three measurements on 500 x 500 μm each)

For worn surfaces the number of measurements will be established depending on surfaces to be investigated. Here the authors did 3 measurements for each roller and there were calculated the average values of the 3D amplitude parameters and several functional parameters as obtained from raw (non-filtered) (examples are given in table 1 and Figure 9). $As\%(S_x)$ is the percentage of up-deviation from the calculated average value:

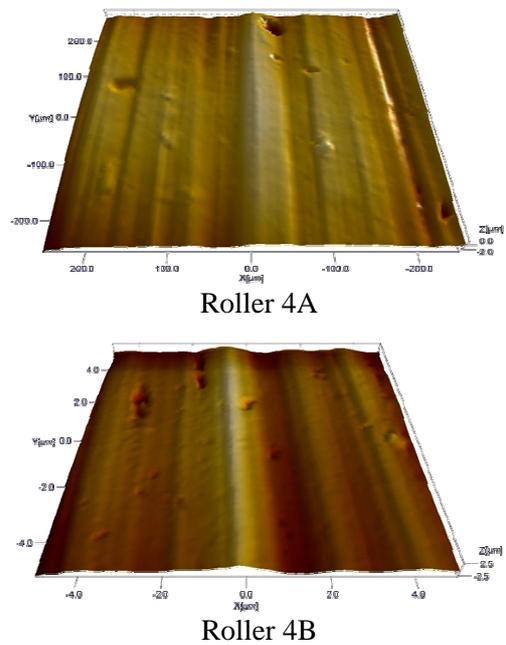
Figure 10. Virtual rebuilding of the tested surfaces for $Q=0.7$ kN, pure rolling

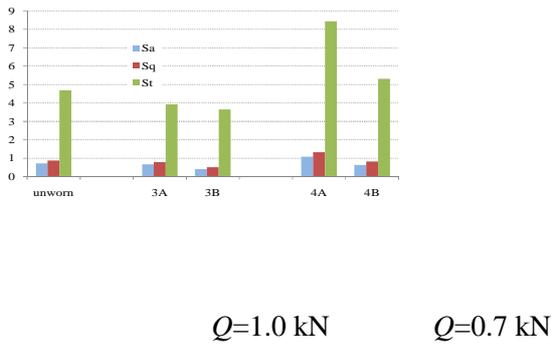
Figure 11. Amplitude parameters S_a , S_q and S_t for the roller surfaces under pure rolling

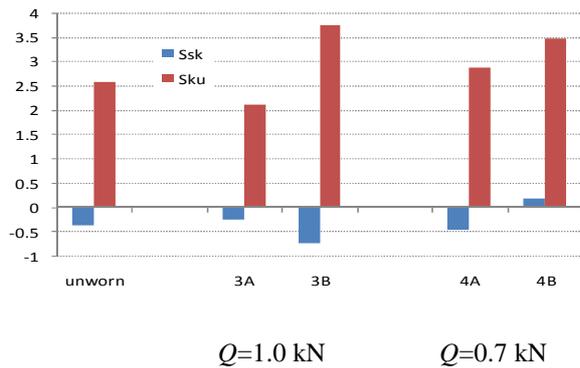
Figure 12. Amplitude parameters S_{sk} and S_{ku} for the roller surfaces under pure rolling

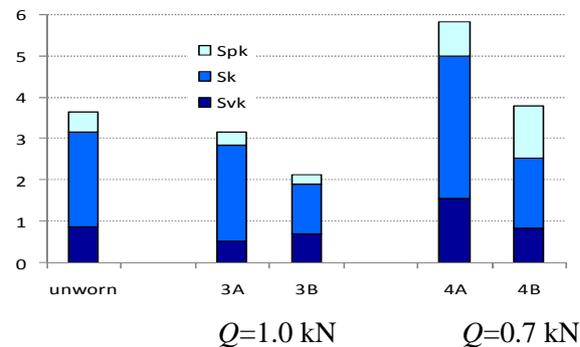
Figure 13. Functional parameters S_k , S_{pk} and S_{vk} for roller surfaces under pure rolling

For pure rolling an increase of the normal load from 0.7 kN to 1.0 kN modifies the functional parameters as given in Figures 11-13, reducing the sum of these parameters as compared to the value obtained on unworn surface and that of tested at $Q=0.7$ kN.
